BELZONA LEVELS AND PROTECTS ERODED CONCRETE

Industry: Chemical & Petrochemical
Application: FPA-Floor Problem Areas
Substrate: Concrete
Products: * Belzona® 4111 (Magma Quartz) ,
* Belzona® 5811 (Immersion Grade) ,

Customer Location: Chemical Plant, North Alabama, USA
Application Date: 2001

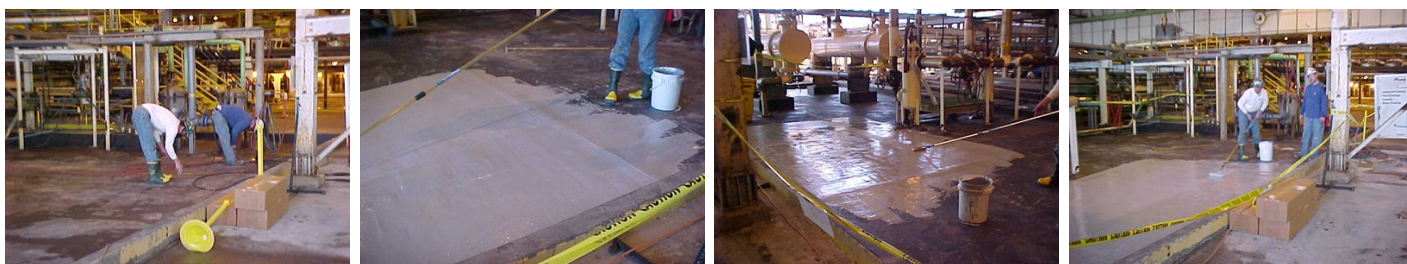
Photograph Descriptions

Acids and caustic mixture had eroded the concrete and EPA made the client repair the concrete so Mercury would not accumulate on the floor.

- * Overall view of the containment area ,
- * Using slurry mix of Belzona® 4111 to level low areas ,
- * First coat of Belzona® 5811 with non-slip aggregate ,
- * Final coat of Belzona® 5811 ,

Chemicals had attacked the concrete

Previous coatings had failed and allowed concrete deterioration. Chosen Belzona system provided the levels required together with excellent resistance to the chemicals involved.

Application was carried out using a modified Belzona Know-How System Leaflet FPA-1. A slurry mix of Belzona® 4111 was used to level floor before coating with Belzona® 5811 with non-slip Aggregate.
