BELZONA SEALS CHEMICAL BUNKERS FROM THE ENVIRONMENT

ID: 1187

Customer Location: *Fertilizer Plant, North Alabama USA*
Application Date: *1999*

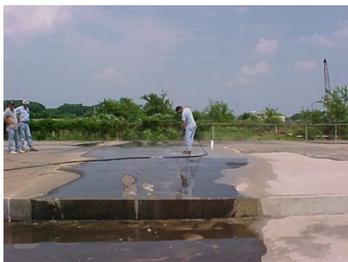
* Cleaning the concrete , * Overall view of cracks conditioned with Belzona® 3911 , * Joints and cracks sealed with Belzona® 3111 , * Spraying coat of clear cladding ,

Application was carried out in accordance with a modified Belzona Know-How System Leaflet RPA-1. Surface prepared by pressure washing then all cracks and joints sealed with Belzona® 3111 system. A coat of clear cladding was applied over the entire concrete storage area.

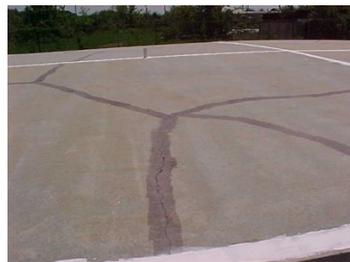
Water was penetrating into the expansion joints and cracks, reacting with old fertilizer which could cause further concrete failure and chemical release into the environment.
