NASA GOES WITH BELZONA

Industry: *Buildings & Structures*
Application: *FPA-Floor Problem Areas*
Substrate: *Concrete*
Products: *<div>Belzona® 4131 (Magma Screed)</div><div>Belzona® 5231 (SG Laminate)</div>*

Customer Location: *NASA, Alabama USA*
Application Date: *2003*

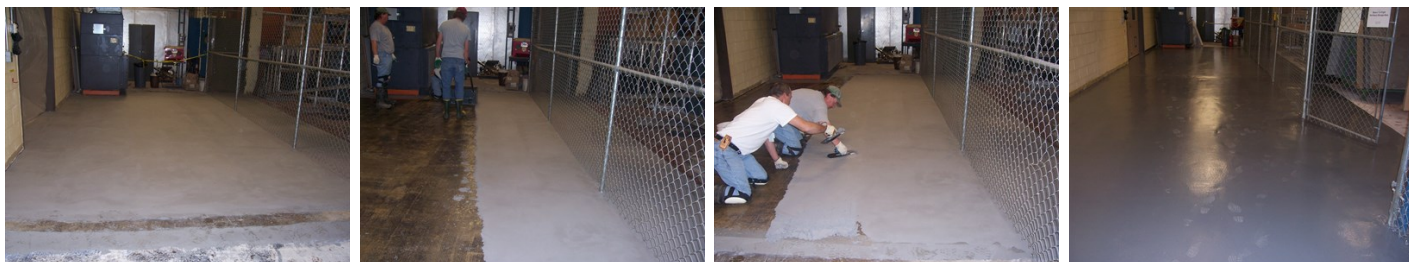
Photograph Descriptions

Old coating and repair materials were spalling and causing uneven areas of the floor. Fork trucks and equipment being moved across it was being damaged.

* Overall view of the floor after preparation by Blastrack , * Screed box laying out the Belzona® 4131 , * Smoothing out the Belzona® 4131 , * Final coats of Belzona® 5231 ,

Machine shop floor was uneven.

Application was carried out in accordance with Belzona Know-How System Leaflet FPA-1. A screed box was used to apply 1/4 inch of Belzona® 4131. After the floor was leveled out Belzona® 5231 was applied in two coats.

Old coating had failed within 1 year. Belzona has been down 3 years without any issues providing an aesthetic non-slip surface.
