NO FLOOR? NO PROBLEM FOR BELZONA

Application: HEX-Heat Exchangers

Customer Location: Industrial Gas Producer, North Alabama

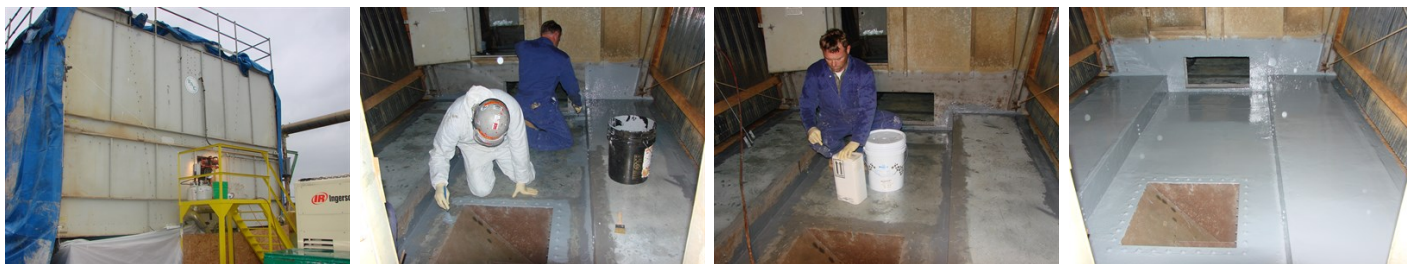
- * Cooling tower protected from the weather ,
- * Sealing the seams with Belzona® 3121 ,
- * First coat of Belzona® 5811 being applied ,
- * Completed application ,

Cooling Tower Floor was corroded away.

Application was carried out in accordance with Belzona Know-How System Leaflets HEX-12 and GSS-3. The floor was abrasive blasted and new sheet metal cold plate bonded in place with Belzona® 1121. The seams were sealed with Belzona® 3121. Two coats of Belzona® 5811 were applied over the cold well surfaces.
