BELZONA SEALS XYLENE CONTAINMENT AREA

ID: 1191

Customer Location: Chemical Plant, North Alabama USA

Application: TCC-Tanks and Chemical Containment Areas

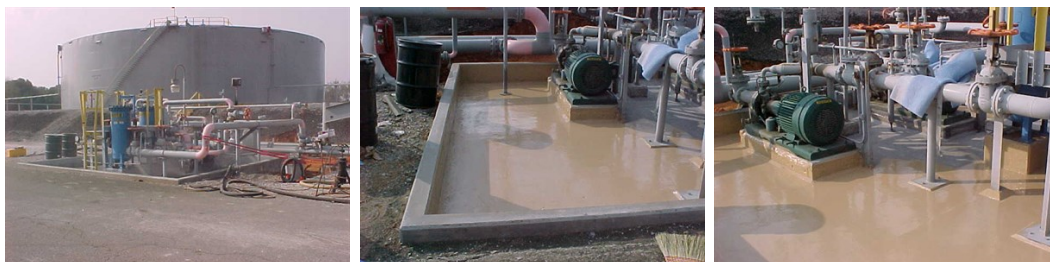
Photograph Descriptions

* Overall view of the containment area , * First coat of Belzona® 5811 applied , * Completed application ,

Xylene was leaking from containment area after spills

Application was carried out in accordance with Belzona Know-How System Leaflet TCC-15. Area abrasive blasted, damaged concrete repaired with Belzona® 4111 and Belzona® 5811 applied by spray.

Other coatings had failed. Belzona was used and is still perfect after 7 years.
