BELZONA SAVES VALUABLE DOWNTIME IN FOOD FACTORY

Customer Location: *Food Processing Facility, Louisiana U.S.A.*

Application: *VPF-Valves, Pipes and Fittings*

Barrel of chiller circulating salt water

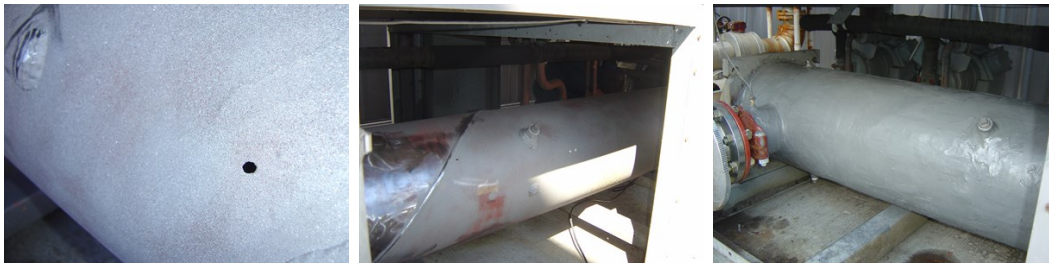
Photograph Descriptions

The carbon steel barrel began to leak due to erosion corrosion.

* Abrasive grit blasting the surface showed hole in substrate , * Contrast between optimal grit blast and grinding , * Completed application , * Review of the procedure by the application crew ,

The application was performed in accordance with Belzona Know-How System Leaflet VPF-11A.

The customer began to cycle salt water through the chiller barrel in an effort to lower the operating temperature of the unit and in turn, accelerate the production rate of the food process. Result was accelerated corrosion damage. A replacement for this barrel would not be available for six months, and a rupture would cause millions in lost production. Belzona saved the day, and was able

to protect the barrel from this catastrophic failure.
