# BELZONA SAVES VALUABLE DOWNTIME IN FOOD FACTORY

Application: VPF-Valves, Pipes and Fittings

Customer Location: Food Processing Facility, Louisiana U.S.A.

Barrel of chiller circulating salt water

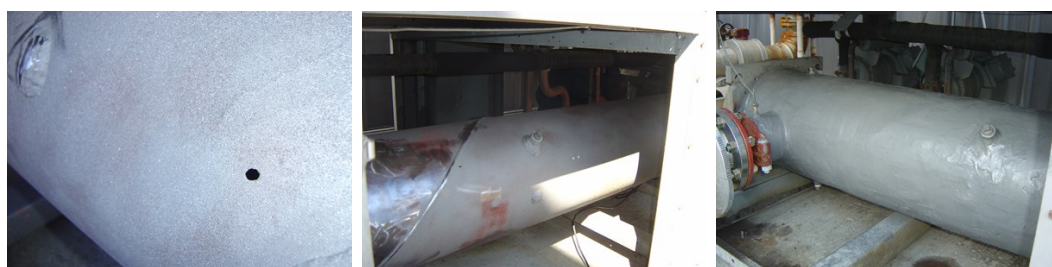
The carbon steel barrel began to leak due to erosion corrosion.

\* Abrasive grit blasting the surface showed hole in substrate , \* Contrast between optimal grit blast and grinding , \* Completed application , \* Review of the procedure by the application crew ,

The application was performed in accordance with Belzona Know-How System Leaflet VPF-11A.

The customer began to cycle salt water through the chiller barrel in an effort to lower the operating temperature of the unit and in turn, accelerate the production rate of the food process. Result was accelerated corrosion damage. A replacement for this barrel would not be available for six months, and a rupture would cause millions in lost production. Belzona saved the day, and was able
