BELZONA KEEPS AIRPORT SAFE FOR TRAVELLERS

Application: FPA-Floor Problem Areas

Customer Location: Airport, Alabama U.S.A.

Expansion joints in passenger terminal.

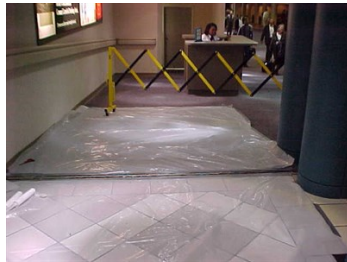
- * The passenger terminal ,
- * One of the application areas ,
- * Problem joint in front of escalator ,
- * Completed Belzona® 2221 application ,

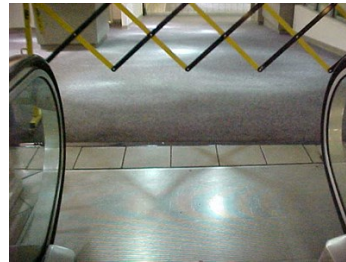
Old sealant was coming out of the joints. Steel plates over the joints did not alleviate the safety concerns.

Application carried out in accordance with Belzona Know-How System Leaflet FPA-6.

Joints still in service after 8 years. Excellent adhesion ensures no trip hazard created by failed sealant.
