COMPETITOR FAILURE BRINGS BELZONA BACK

Customer Location: Power Plant, Birmingham, Alabama
U.S.A.Application: TCC-Tanks and Chemical Containment
Areas

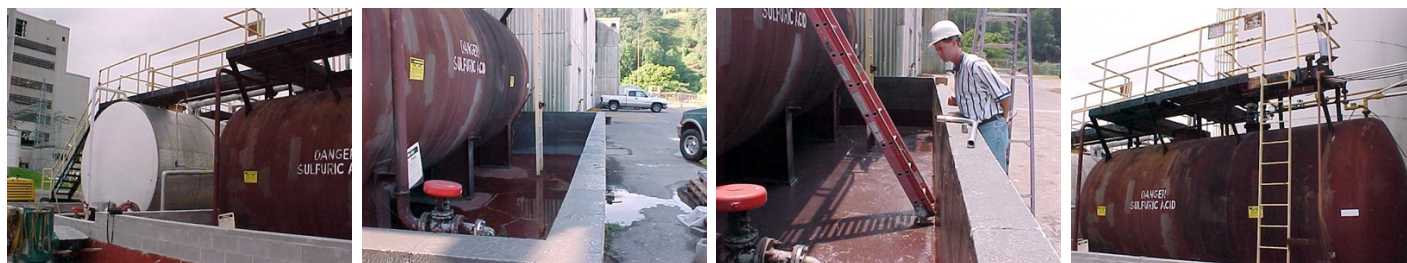
Photograph Descriptions

Competitor coating failed within two years. Belzona was asked to coat the concrete since Belzona® 4311 had been on the sulfuric acid tank itself for almost 12 years.

- * The acid and caustic containment area ,
- * Concrete damage ,
- * Coated containment area ,
- * Belzona® 4311 on the acid tank after 12 years ,

Sulfuric acid containment area. Failed coating allowed chemical leakage into the environment.

Application was carried out in accordance with Belzona Know-How System Leaflets TCC-9 and TCC-15. Damaged concrete was repaired with Belzona® 4111. Coated the acid side of the containment area with Belzona® 4311 and the caustic side with Belzona® 5811.

Belzona® 4311 was applied to the acid tank in 1988 and 12 years later was still perfect other than a little staining. The client had used a cheap coating in containment area first and after it failed decided to spend a little more money to make it last a long time. 8 years later and minor repairs are all that are needed on the Belzona.
