# BELZONA SOLVES PROBLEM WITH AGITATOR BLADES

ID: 120

Industry: *Sugar*  
Application: *FBC-Fans, Blowers and Compressors*

Customer Location: *Sugar Beet Mill in Italy*  
Application Date: *1992*

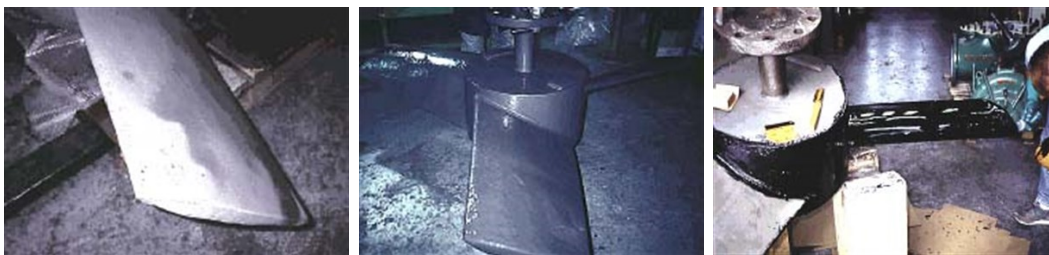
## Photograph Descriptions

*Abrasive solids in settling tank caused erosion on the surface of the agitator blades.*

- \* Damaged base of agitator. ,
- \* Blades rebuilt with Belzona® 1000 Series product. ,
- \* Application of Belzona® 2000 Series product. ,

Agitator in settling tank of wastewater treatment station in a sugar beet mill

The application was carried out in accordance with a modified version of Belzona Know-How Leaflet FBC-1.

When damage is due primarily to abrasion, the recommended solution is to rebuild and coat with the Belzona® Ceramic Metal System respectively. The Belzona® 2000 Series Elastomeric Polymers also may be used when impact and abrasion are the contributing factors.
