# BELZONA SEALS 20,000sq.ft.CONTAINMENT AREA

**Customer Location:** Chemical Plant, North Alabama U.S.A.

**Application:** TCC-Tanks and Chemical Containment Areas

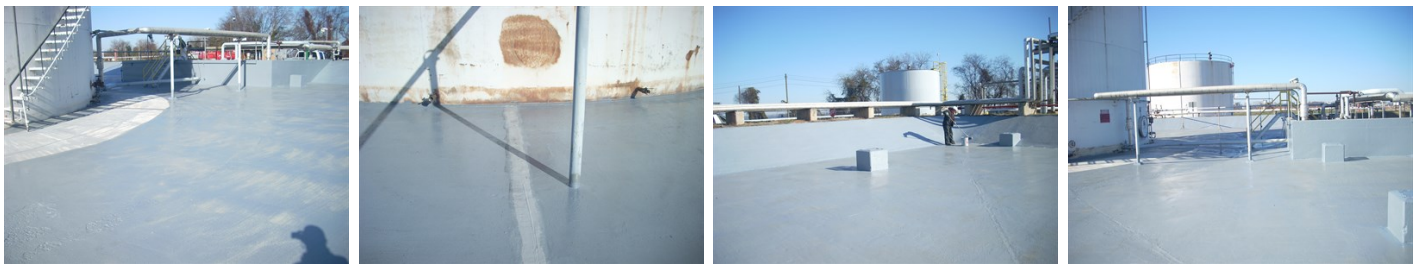
Cracks and failed coating over the concrete dyke.

\* Over view of the containment area , \* Close up of the expansion joints , \* 2nd coat of Belzona® 5811 applied , \* Application completed with final coat of Belzona® 5111 ,

Application was carried out using a modified Belzona Know-How System Leaflet TCC-15. The concrete was high Pressure Water Jetted to remove loose coating and expansion joint sealant. Joints then sealed with Belzona® 4521. 2 coats of Belzona® 5811 and a top coat of Belzona® 5111 for UV Protection applied to entire area.
