BELZONA PROTECTS BLAST FURNACE SCRUBBER

ID: 1203

Customer Location: Steel Plant, Alabama
Application Date: 2005

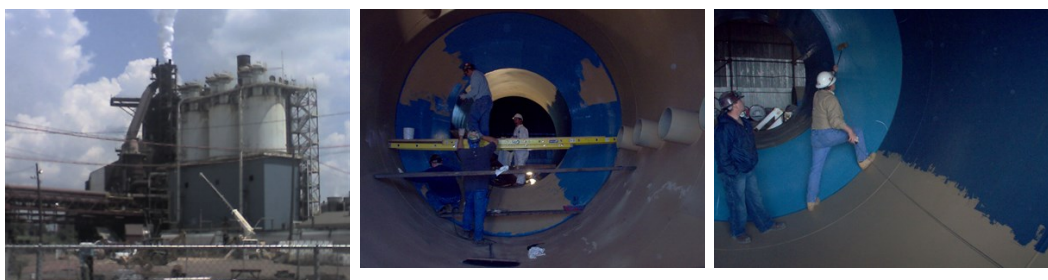
Photograph Descriptions

Blast Furnace gases and particulates had corroded the original venturi scrubber. Items were building up on the steel and the lower portions were eroding due to abrasion.

* Overview of the blast furnace and the scrubber , * Beige Belzona® 5811 applied and Belzona® 1341 and darker blue Belzona® 1321 being applied , * Spark testing the Belzona® 1341 , * View of the completed project ,

Application was carried out in accordance with Belzona Know-How System Leaflet TCC-5. Belzona® 5811 was sprayed over the entire vessel as a holding primer. On the intake of the vessel Belzona® 1341 was used for build up problems. Belzona® 1321 was used in the high erosion areas.

Due to Belzona® 1341 lasting in the piping going to the scrubber, the client asked for the Belzona® 1341 to coat the entire scrubber vessel. Belzona® 1321 used to give extra abrasion resistance where required.
