# BELZONA BRIGHTENS UP HOSPITAL LAUNDRY FLOOR

ID: 1205

Customer Location: Medical Center, Anniston, Alabama USA  
Application Date: December 2007

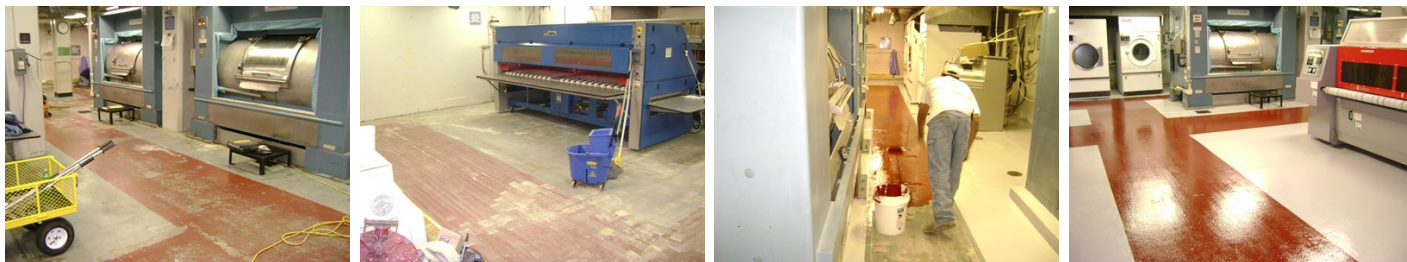
*The coating that was currently on the floor was worn and causing slip hazards for the employees.*

\* Floor prior to being prepared , \* Floor after being abraded , \* Belzona® 5231 being applied , \* Completed floor ,

Application was carried out using a modified Belzona Know-How System Leaflet FPA-3. The concrete was abraded to remove the existing coating and profile the concrete. Areas masked off and Belzona® 5231 Red and Gray used for demarcation.
