BELZONA PROTECTS 98% SULFURIC ACID CONTAINMENT AREA

ID: 1207

Industry: Power
Application: TCC-Tanks and Chemical Containment Areas
Substrate: Concrete
Products: Belzona® 4311 (Magma CR1)

Customer Location: Power Plant, Alabama USA
Application Date: December 2007

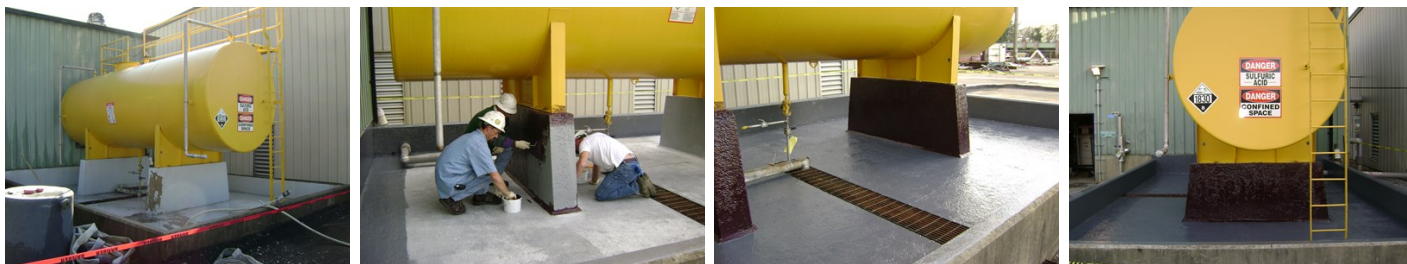
Photograph Descriptions

Sulfuric Acid containment area coating had failed and needed re-coating.

* Old coating being removed , * Belzona® 4311 being applied , * & 4. Completed application ,

Application was carried out in accordance with Belzona Know-How System Leaflet TCC-15. Old coating was removed using high pressure water blasting. Belzona® 4311 was applied to both containment and tank stands.
