UNIVERSITY STUDIES BELZONA FLOOR SOLUTION

Industry: Buildings & Structures
Application: FPA-Floor Problem Areas
Substrate: Concrete
Products: <div>Belzona® 4111 (Magma Quartz)</div>
<div>Belzona® 5231 (SG Laminate)</div>

Customer Location: University, St Louis, Missouri U.S.A.
Application Date: Spring 2008

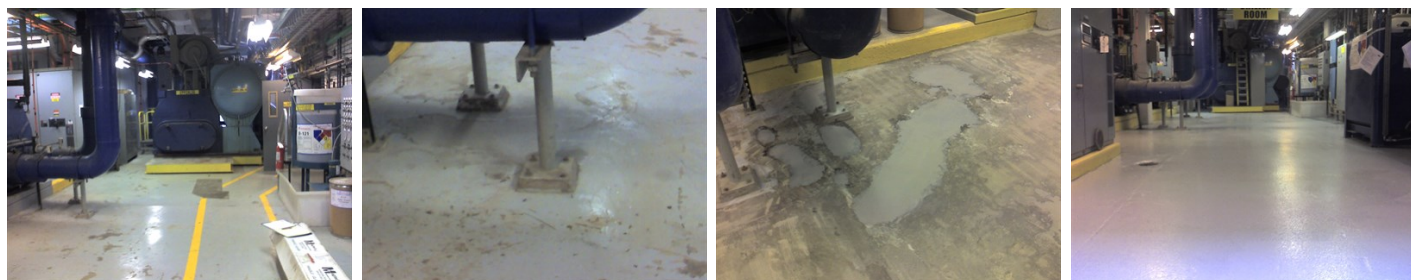
Photograph Descriptions

Floor caused trip hazards for employees and previous coatings required annual refurbishment.

- * Floor before repairs and coating ,
- * Close up of floor problems ,
- * Holes in floor repaired with Belzona® 4111 ,
- * Floor after coating with Belzona® 5231 ,

Application was carried out in accordance with Belzona Know How System Leaflets FPA-1 & -3.
