BELZONA PROTECTS VERTICAL LIFT PUMP IMPELLER

ID: 1215

Industry: Chemical & Petrochemical
Application: CEP-Centrifugal Pumps
Substrate: Bronze
Products: * Belzona® 2141 (ACR-Fluid Elastomer) ,

Customer Location: Chemical Plant, Texas
Application Date: 2006

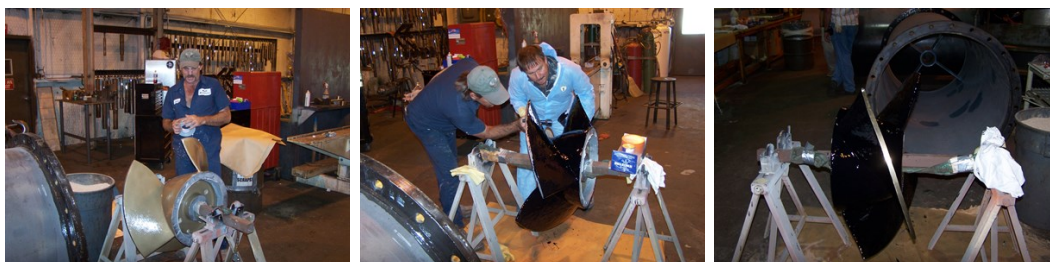
Photograph Descriptions

Due to the damage caused by the severe cavitation, costly rebuilding and rebalancing of the impeller was required on at least an annual basis.

- * Vertical lift impeller with Belzona® 2941 conditioner applied ,
- * Inspection of impeller during coating process ,
- * Coating completed, awaiting installation ,

Application was carried out in accordance with Belzona Know-How System Leaflet CEP-3.

Pump still in service and performing satisfactorily almost 3 years later. Annual overhaul on these type pumps can run as much as \$30,000 (3 years approx. \$90,000 savings.) Belzona product was less than \$3,000.
