# BELZONA PROTECTS VERTICAL LIFT PUMP IMPELLER

ID: 1215

Customer Location: Chemical Plant, Texas  
Application Date: 2006

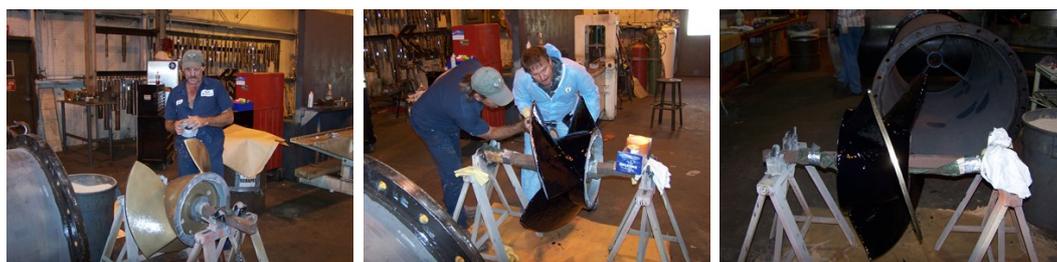
Due to the damage caused by the severe cavitation, costly rebuilding and rebalancing of the impeller was required on at least an annual basis.

- \* Vertical lift impeller with Belzona® 2941 conditioner applied ,
- \* Inspection of impeller during coating process ,
- \* Coating completed, awaiting installation ,

Application was carried out in accordance with Belzona Know-How System Leaflet CEP-3.

Pump still in service and performing satisfactorily almost 3 years later. Annual overhaul on these type pumps can run as much as \$30,000 (3 years approx. \$90,000 savings.) Belzona product was less than \$3,000.
