# BELZONA PROTECTS WASTEWATER PUMP

ID: 1216

Application: CEP-Centrifugal Pumps

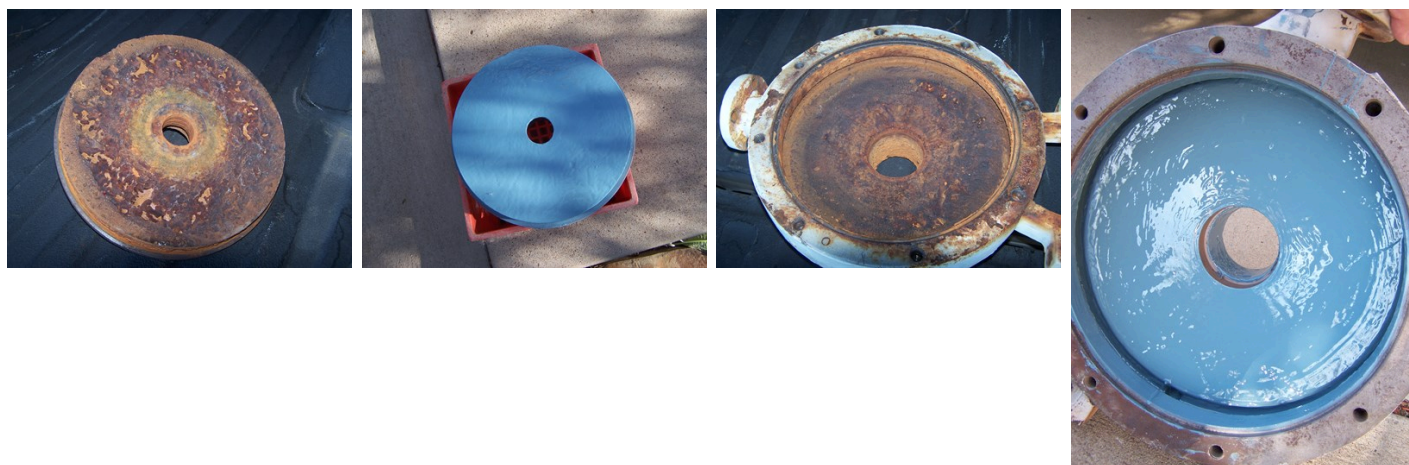
## Photograph Descriptions

Strong chemicals within the wastewater process were attacking pump components which caused pitting and degradation of the carbon steel substrate resulting in loss of performance, loss of pump efficiency and frequent pump replacement.

\* Damaged wastewater pump head , \* Pump head rebuilt and coated , \* Damaged pump housing , \* Pump housing rebuilt and coated ,

Wastewater pump in chemical company was experiencing severe corrosion from chemical attack.

Application was carried out in accordance with Belzona Know-How System Leaflets CEP-1 & -3.

Annual replacement cost of pump was between \$15-20k. Belzona repair and coating was approximately \$1200. Two years later, the pump is exhibiting no signs of performance loss resulting in an estimated savings of \$30k.
