# BELZONA PROTECTS WASTEWATER PUMP

ID: 1216

Application: CEP-Centrifugal Pumps

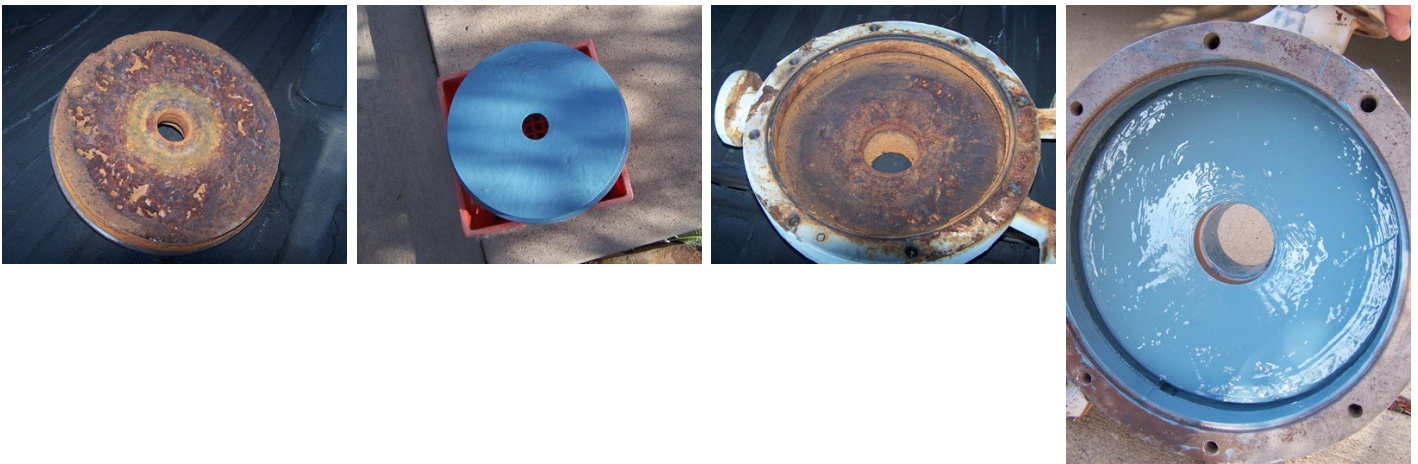
Strong chemicals within the wastewater process were attacking pump components which caused pitting and degradation of the carbon steel substrate resulting in loss of performance, loss of pump efficiency and frequent pump replacement.

\* Damaged wastewater pump head , \* Pump head rebuilt and coated , \* Damaged pump housing , \* Pump housing rebuilt and coated ,

Wastewater pump in chemical company was experiencing severe corrosion from chemical attack.

Application was carried out in accordance with Belzona Know-How System Leaflets CEP-1 & -3.

Annual replacement cost of pump was between \$15-20k. Belzona repair and coating was approximately \$1200. Two years later, the pump is exhibiting no signs of performance loss resulting in an estimated savings of \$30k.
