BELZONA OVERCOMES WEAR PROBLEMS CAUSED BY CORN

ID: 1219

Customer Location: Corn Processing Plant, West Tennessee
USA

Application: SHM-Solids Handling Machinery

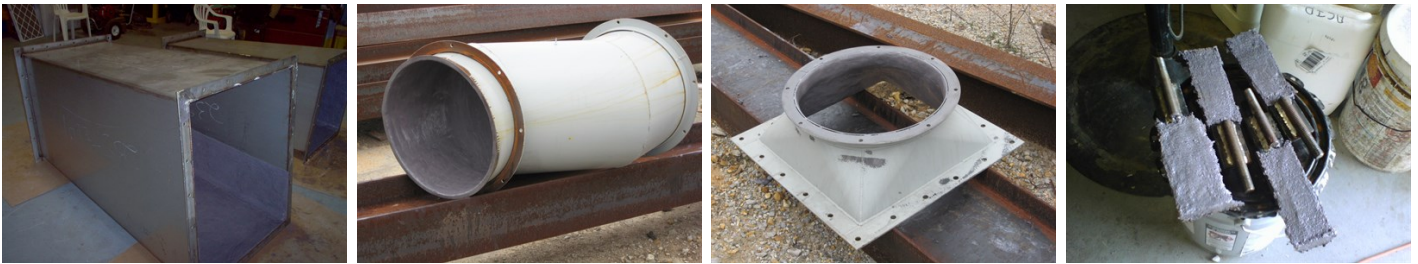
Photograph Descriptions

Carbon Steel was lasting less than 1 year and down time was a continuous problem in the plant. A lining which would take the wear from corn and soyabean was needed.

* A Chute Lined with Belzona® 1812 , * A Spout Lined with Belzona® 1812 , * A Transition Piece Lined with Belzona® 1812 , * Mixing Blades protected with Belzona® 1812 ,

Applications were carried out in accordance with Belzona Know-How System Leaflet SHM-13. After grit blasting the newly fabricated chutes, spouts, and mixing blades, 1/2 inch of Belzona® 1812 was applied to the wear areas.

Belzona has doubled and in some cases tripled the life of the equipment. Previous linings had delaminated and contaminated the product.
