# BELZONA OVERCOMES WEAR PROBLEMS CAUSED BY CORN

ID: 1219

Customer Location: Corn Processing Plant, West Tennessee  
USA

Application: SHM-Solids Handling Machinery

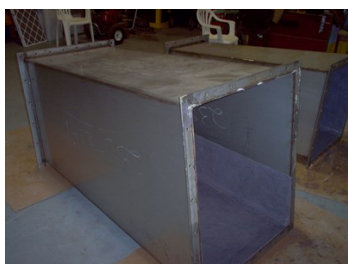
\* A Chute Lined with Belzona® 1812 , \* A Spout Lined with Belzona® 1812 , \* A Transition Piece Lined with Belzona® 1812 , \* Mixing Blades protected with Belzona® 1812 ,

Applications were carried out in accordance with Belzona Know-How System Leaflet SHM-13. After grit blasting the newly fabricated chutes, spouts, and mixing blades, 1/2 inch of Belzona® 1812 was applied to the wear areas.
