BELZONA PROVIDES SOLUTION TO WATER INJECTION PUMP

ID: 122

Customer Location: Sugar Cane Mill in Australia
Application Date: 1996

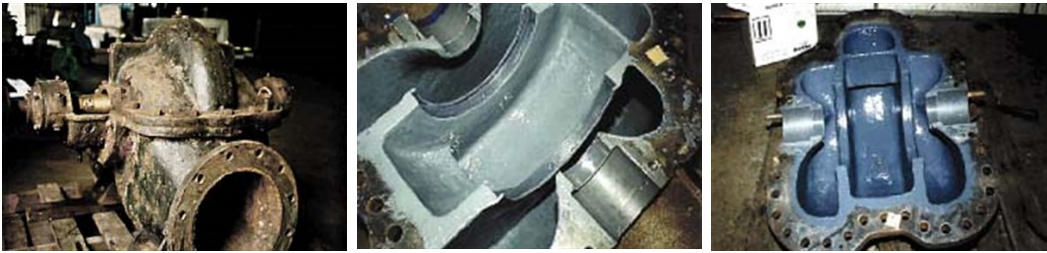
Photograph Descriptions

General erosion/corrosion on pump volute, wear ring seats and stuffing box

- * Split casing water injection pump. ,
- * Rebuilt wear ring seat and stuffing box. ,
- * Completely refurbished casing. ,

The application was carried out in accordance with Belzona Know-How Leaflets CEP-1, CEP-2 and CEP-3.
