# BELZONA PROVIDES MORE GRIP AND REDUCES ACCIDENTS

ID: 1220

**Customer Location:** Corn Processing Plant, West Tennessee  
**Application Date:** 2007

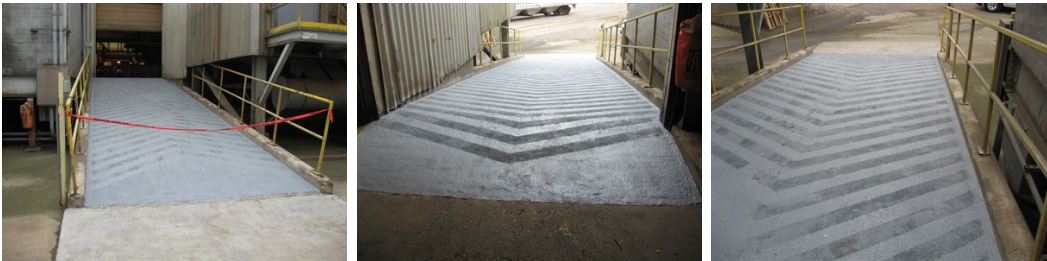
Fork trucks were slipping causing accidents on this slippery loading ramp. Old coatings had failed to improve traction.

- \* Ramp coated with Belzona 5811 ,
- \* Close look at the ramp ,
- \* Completed application after application of Belzona® 5111 ,

Application was carried out in accordance with modified Belzona System Leaflet FPA-8. After abrasive blasting the concrete to roughen and remove the old coating, Belzona® 5811 was applied in chevron pattern and loaded to rejection with coarse grade of aggregate. The entire system was overcoated with Belzona® 5111 to provide UV protection.
