# BELZONA SEALS CONCRETE COOLING TOWER BASINS

ID: 1224

Application: *HEX-Heat Exchangers*

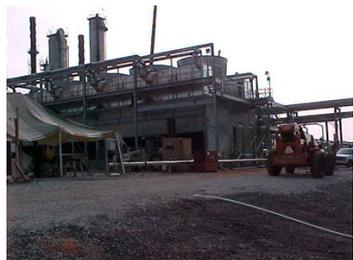
\* Cooling Tower overview , \* Walls repaired with Belzona® 4111 , \* First coat of Belzona 5811 being applied , \* Final Coat of Belzona 5811 applied ,

Concrete Basins in cooling tower were leaking shortly after the start up of a new unit.

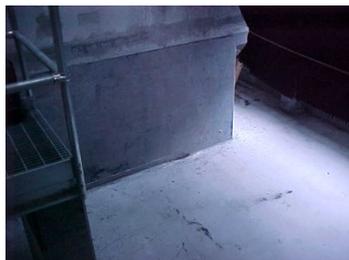
*Cracks in the concrete were allowing water leaks into the environment.*

Application was carried out in accordance with Belzona Know-How System Leaflets HEX-6 and -7. After grit blasting the concrete, cracks were sealed with Belzona® 4111 then coated with a reinforced Belzona® 5811 system. The entire basin was then coated with Belzona® 5811.
