# BELZONA REFURBISHES RUBBER-LINED PUMP

Industry: Sugar  
Application: SHM-Solids Handling Machinery

Customer Location: Sugar Cane Mill in Texas, U.S.A.  
Application Date: 1985

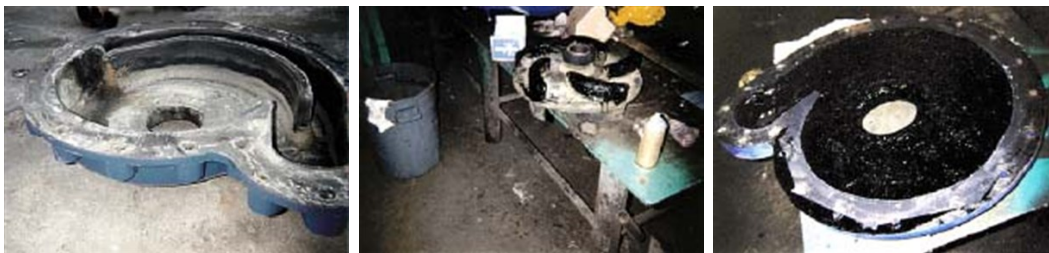
## Photograph Descriptions

*Pump casing and impeller suffer from erosion/corrosion due to the abrasive nature of the ash slurry.*

- \* View of uncoated casing. ,
- \* Application of coating material to impeller. ,
- \* Casing completely coated with Belzona® 2000 Series product. ,

The application was carried out in accordance with a modified version of Belzona Know-How Leaflet SHM-9.

The Belzona® 2000 Series Elastomeric Polymers afforded the casing with the necessary protection against abrasion and impact.
