# BELZONA REBUILDS LOADER PIN BUSH HOUSING

ID: 1230

Customer Location: *Metals Recycling Facility, Missouri U.S.A.*  
Application Date: *April 2008*

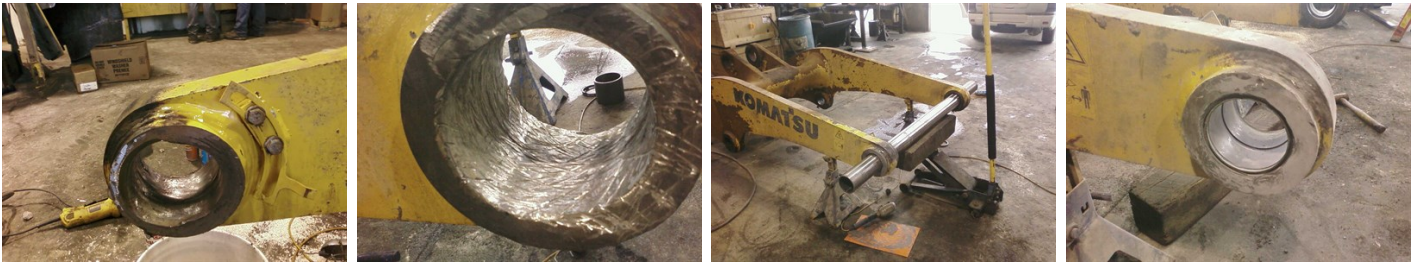
*Wear in the pin bush housings. Conventional welding required the loader to be out of service too long.*

\* Damaged pin bush housing , \* Surface preparation complete , \* Dummy shaft installed to maintain alignment , \* Finished and ready for service ,

Pin bushing in Komatsu Loader. The specific bushings are where loader arms connect to the loader body.

Repairs were completed in accordance with Belzona Know How System Leaflet MPT-8.

Repairs were completed for 1/10th the cost of welding/line boring and was returned to service the next day! The Belzona Technical Consultant was on site to provide training and oversight of the repair to the customers maintenance crew. The customer plans to continue to use Belzona and save on this common repair!
