# BELZONA "DELIVERS" A SANITARY FLOORING SOLUTION

ID: 1232

Industry: *Buildings & Structures*  
Application: *FPA-Floor Problem Areas*  
Substrate: *Plywood*  
Products: *\* Belzona® 5811 (Immersion Grade) ,*

Customer Location: *Church charity organization, Texas*  
Application Date: *2006*

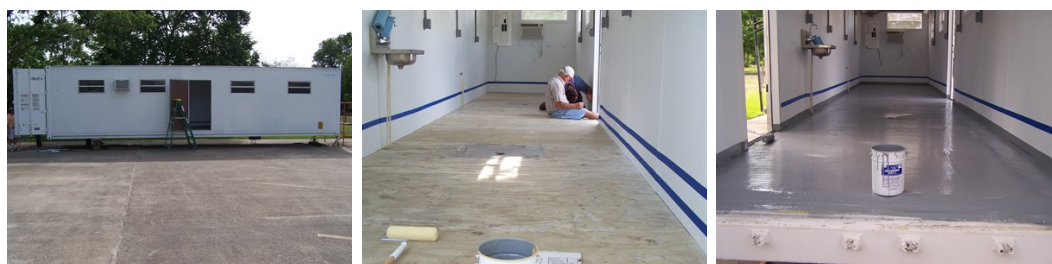
*The raw plywood floor with no sealant would be difficult to maintain and keep clean in an area that required a very sanitary environment.*

- \* The portable birthing center ,
- \* Floor prior to coating with walls taped off ,
- \* Finished Belzona® 5811 flooring application ,

Application was carried out in accordance with Belzona Know-How System Leaflet FPA-3. The walls were taped off approximately 2 inches up the vertical edge, sanded, cleaned then coated with two coats of Belzona® 5811 with minimal Surefoot aggregate added during the first coat process.
