# BELZONA PROTECTS CONCRETE IN BIODIESEL PLANT

**Industry:** Chemical & Petrochemical  
**Application:** TCC-Tanks and Chemical Containment Areas  
**Substrate:** concrete  
**Products:** \* Belzona® 5811 (Immersion Grade),

**Customer Location:** Biodiesel Manufacturer, Memphis, TN  
**Application Date:** 2008

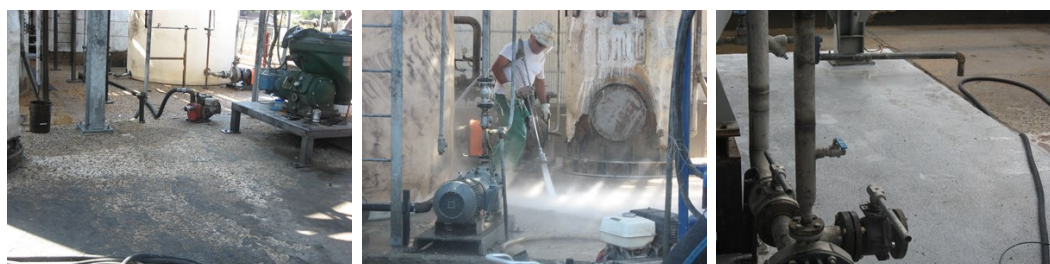
Biodiesel attacked the concrete substrate causing erosion leading to unsafe walking conditions.

- \* Concrete pad before repair ,
- \* Pad during repair ,
- \* Completed project ,

Application was carried out in accordance with Belzona Know-How System Leaflet TCC-15. Surface was prepared with 20,000 psi pressure washer which removes deteriorated concrete and removes contamination at the same time. This repair was done over a 2 day period. Aggregate was applied into the Belzona® 5811 to create a non-slip walking surface.
