BELZONA PROTECTS CONCRETE IN BIODIESEL PLANT

ID: 1234

Customer Location: Biodiesel Manufacturer, Memphis, TN
Application Date: 2008

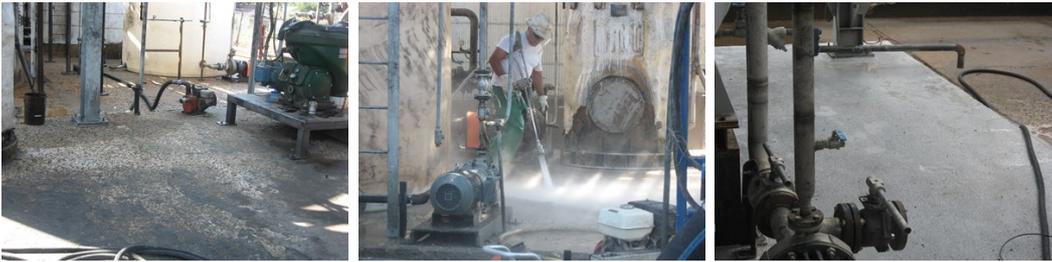
Photograph Descriptions

Biodiesel attacked the concrete substrate causing erosion leading to unsafe walking conditions.

- * Concrete pad before repair ,
- * Pad during repair ,
- * Completed project ,

Application was carried out in accordance with Belzona Know-How System Leaflet TCC-15. Surface was prepared with 20,000 psi pressure washer which removes deteriorated concrete and removes contamination at the same time. This repair was done over a 2 day period. Aggregate was applied into the Belzona® 5811 to create a non-slip walking surface.

The Belzona system was applied with minimal downtime and provides both protection from further concrete deterioration whilst providing a safe walking surface.
