# BELZONA REPAIRS VACUUM PUMP ROTOR

Industry: Sugar  
Application: CEP-Centrifugal Pumps  
Substrate: Cast Iron  
Products: \* Belzona® 1111 (Super Metal) ,  
\* Belzona® 1341 (Supermetalgilde) ,

Customer Location: Sugar Cane Mill in Minnesota, U.S.A.  
Application Date: 1993

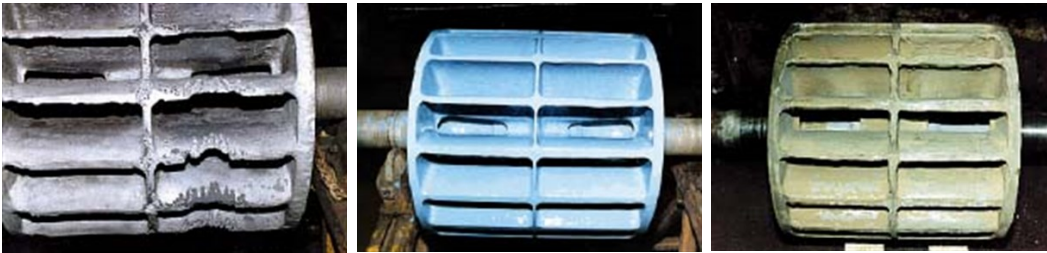
*Cavitation damage was the principal problem on this rotor.*

- \* Extensive damage of vacuum pump easily visible. ,
- \* Refurbished rotor. ,
- \* Rotor after many years in service. ,

The application was carried out in accordance with Belzona Know-How Leaflet CEP-1.

Belzona's repair system has proven resistant to cavitation. The repair has lasted over five years.
