CLASSIC BELZONA SHAFT REPAIR AT CEMENT PLANT

ID: 1241

Industry: *Cement*
Application: *MPT-Mechanical Power Transmission*

Customer Location: *Cement plant, Nazareth, PA*
Application Date: *November 2005*

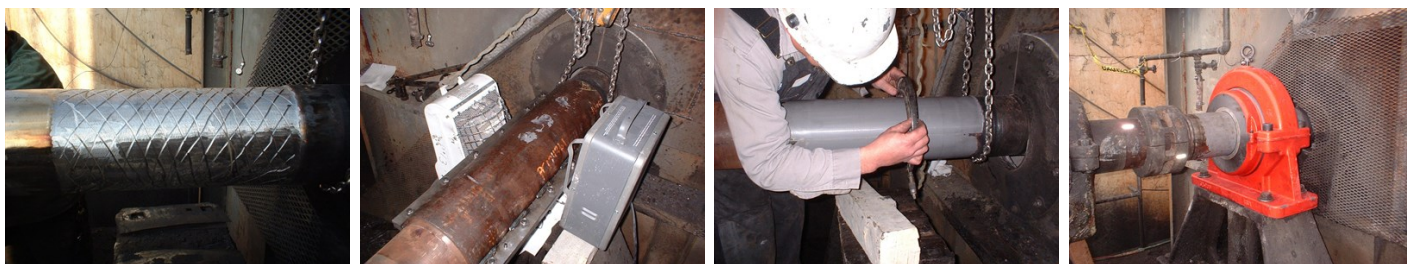
Photograph Descriptions

Kilns were to be shut down in approximately 4-6 weeks but failed split bearing caused scoring of shaft requiring urgent repair.

* Shaft prepared , * Split sleeve former , * Rebuilt shaft being measured , * Back in service ,

Forced draft fan shaft for the kilns.

Application was completed in accordance with Belzona Know-How System Leaflet MPT-2.

Application completed with minimal downtime saving thousands of dollars in lost production. Belzona cost is minimal in comparison to alternatives. The replacement bearing alone cost \$10K.
