# BELZONA REPAIRS OIL TANK LEAK

ID: 1243

Customer Location: Oil Refinery, Thailand

Application Date: November 2008

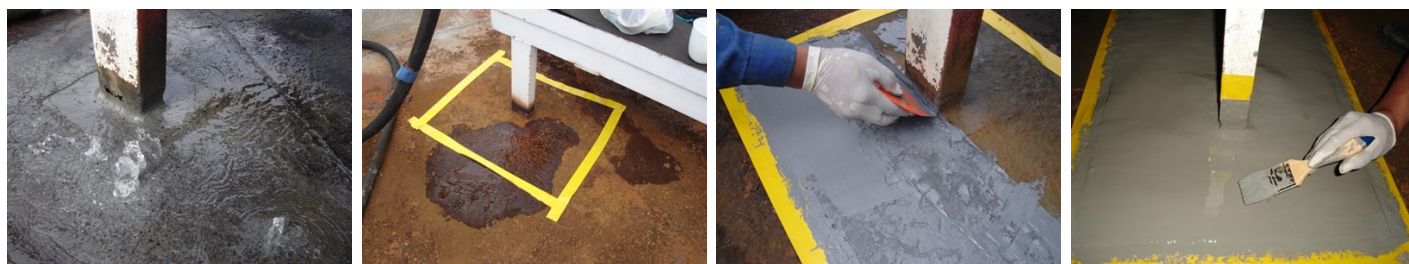
## Photograph Descriptions

The roof deck of the tank had been subjected to severe corrosion leading to a local leak of the oil vapour. This was very hazardous to the plant operation and there was also a risk of rain water contamination into the tank.

\* Leaking oil tank , \* Prepared application area , \* Applying Belzona® 1161 , \* Applying Belzona® 5831 ,

Application was carried out in accordance with Belzona Know-How System Leaflets TCC-1 & -5. The surface was cleaned by wet sand blasting to avoid hot work and spark. Belzona® 1161 was then used in conjunction with four layers of Belzona reinforcement sheets to prevent further leakage. Belzona® 5831 then applied to protect against further corrosion.

The surface tolerant properties of Belzona® 1161 & Belzona® 5831 allowed the application to be done on a wet blasted and oil contaminated surface which provided a quality repair safely.
