BELZONA REPAIRS OIL TANK LEAK

Customer Location: Oil Refinery, Thailand

Application: TCC-Tanks and Chemical Containment Areas

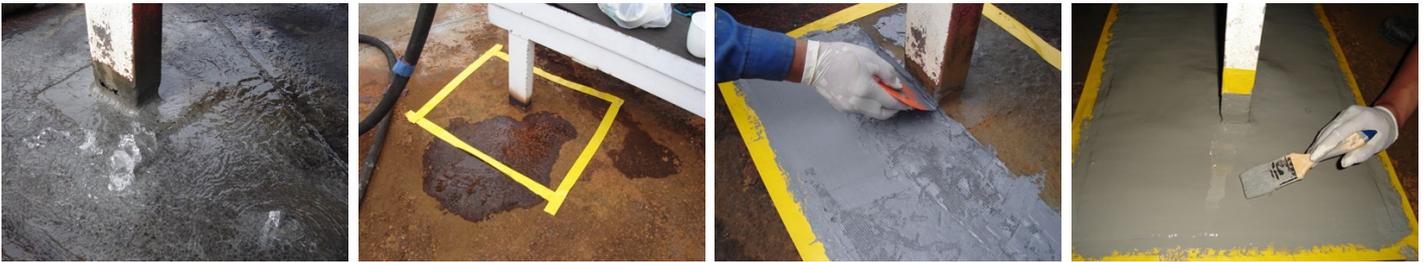
Photograph Descriptions

The roof deck of the tank had been subjected to severe corrosion leading to a local leak of the oil vapour. This was very hazardous to the plant operation and there was also a risk of rain water contamination into the tank.

* Leaking oil tank , * Prepared application area , * Applying Belzona® 1161 , * Applying Belzona® 5831 ,

Application was carried out in accordance with Belzona Know-How System Leaflets TCC-1 & -5. The surface was cleaned by wet sand blasting to avoid hot work and spark. Belzona® 1161 was then used in conjunction with four layers of Belzona reinforcement sheets to prevent further leakage. Belzona® 5831 then applied to protect against further corrosion.

The surface tolerant properties of Belzona® 1161 & Belzona® 5831 allowed the application to be done on a wet blasted and oil contaminated surface which provided a quality repair safely.
