# STORAGE TANK ROOF REPAIRED USING BELZONA

ID: 1247

Customer Location: Petroleum Company, Egypt.  
Application Date: December, 2008.

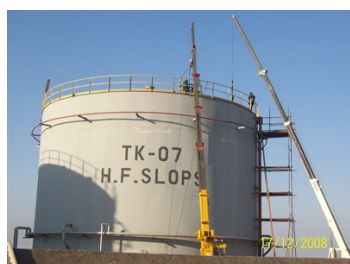
- \* General view of the tank ,
- \* The holes in the roof tank ,
- \* Using two winches to carry the metal sheets & technicians ,
- \* Application completed ,

Heavy slops tank.

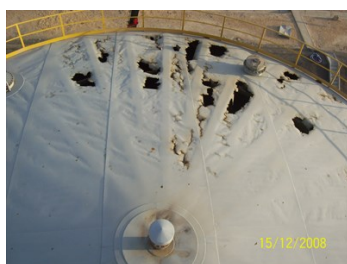
Several holes in the tank roof.

Application was carried out in accordance with Belzona Know-How System Leaflet TCC-1. Metal patches were formed to cover the holes and were bonded into place using Belzona Marine metal. The unsafe roof forced the applicators to use winches to support the plates and technicians on the tank to solve the problem.
