# BELZONA PROTECTS MAIN CIRCULATION PUMP IN NUCLEAR POWER STATION

Customer Location: Nuclear Power Plant in Mexico

Application Date: September 1991

Main cooling water circulation pump

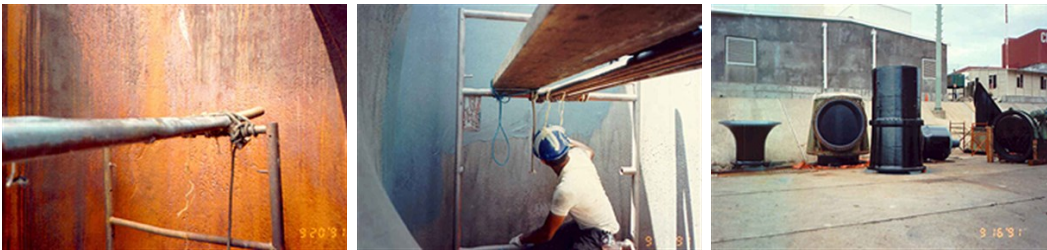
All the pump components suffered from erosion/corrosion due to the use of sea water as the cooling medium. The effects were exacerbated by entrainment, cavitation and bimetallic corrosion.

- \* Surface of pump prior to application of Belzona® 1311 showing damage ,
- \* Applying Belzona® 1311 ,
- \* Components of pump ready for reassembly, external surfaces protected with Belzona® 5811 ,

In accordance with Belzona Know-How Leaflets CEP-5, CEP-3 and CEP-4.

Using the Belzona repair method cost the customer 30% more than using the conventional repair materials. Whereas the usual repairs lasted no more than a year before maintenance, this repair, completed nearly five years, ago is still intact. The saving to the customer, after the initial outlay of £60,000, is £45,000 and five days of downtime every year.
