# BELZONA REPAIR AND PROTECTION OF DESALTER

Customer Location: Petroleum Company, Egypt.

Application: TCC-Tanks and Chemical Containment Areas

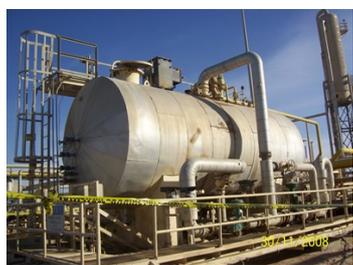
\* General view of the Desalter , \* Rebuilding the pitting areas in the lower half , \* Finishing the coating of the upper half , \* Application completed ,

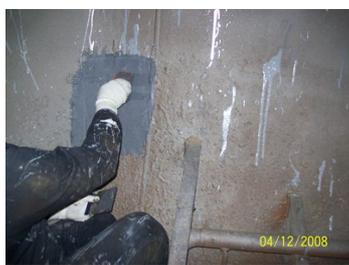
Several pitted areas in the lower half of the vessel needed to be rebuilt. Protection then required particularly for high salt levels in lower half of vessel.

Application was carried out in accordance with Belzona Know-How System Leaflet TCC-5. After filling the pitted areas using Belzona® 1311, upper half of vessel protected with Belzona® 5891 and Belzona® 1391 applied to the lower half.
