# BELZONA REPAIR OF CONDENSATE TANK

ID: 1253

Application: TCC-Tanks and Chemical Containment Areas

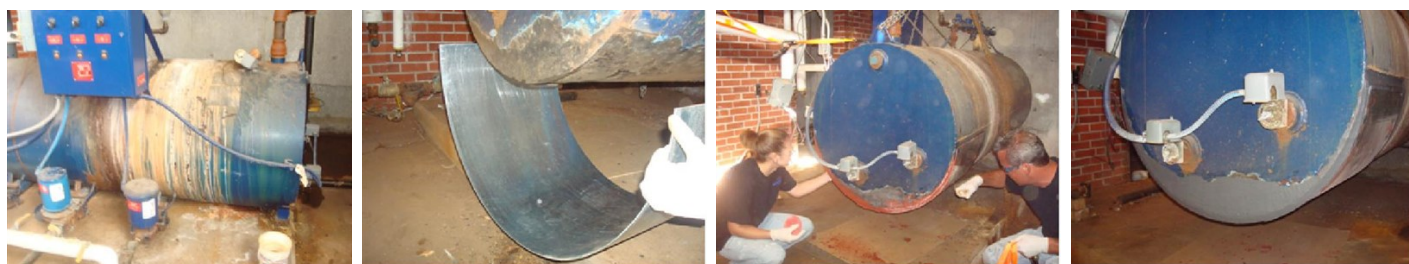
## Photograph Descriptions

During summer maintenance of this facilities boiler plant, the condensate return tank was found to be severely corroded and leaking, with concern for its ability to make it through another heating season.

\* The leaking tank , \* Rolled plate , \* Plate bonded with Belzona® 4181 , \* Completed application ,

Leaking condensate return tank

Application was carried out using a modified Belzona Know-How System Leaflet TCC-1. The tank was lifted for access and mechanically prepared with the MBX Bristle Blaster. A heavy gauge steel plate was fabricated and bonded into place with Belzona® 4181. Belzona® 1311 was then used to reinforce the tank ends.
