BELZONA ROOF SYSTEM PROVIDES ADDED BENEFITS

ID: 1254

Application: RPA-Roof Problem Areas

Substrate: Rolled roofing, mastic, brick and clay tile

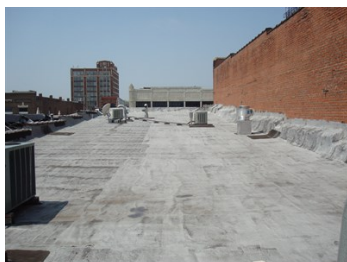
Minor leaks were causing unsanitary conditions in the kitchen and the HVAC system could not keep up with major temperature and humidity fluctuations causing discoloration in the highly decorative chocolates.

* Storefront of world renowned chocolate maker , * View of the roof prior to remediation , * Application in progress , * Completed application ,

Application was carried out in accordance with Belzona Know-How System Leaflets RPA-1, -8, -10 and -11.
