# BELZONA GETS GRIP ON CONVEYOR SLIPPAGE

ID: 1256

Industry: Mining & Quarrying  
Application: SHM-Solids Handling Machinery

Customer Location: Quarry, Central Missouri  
Application Date: January 2009

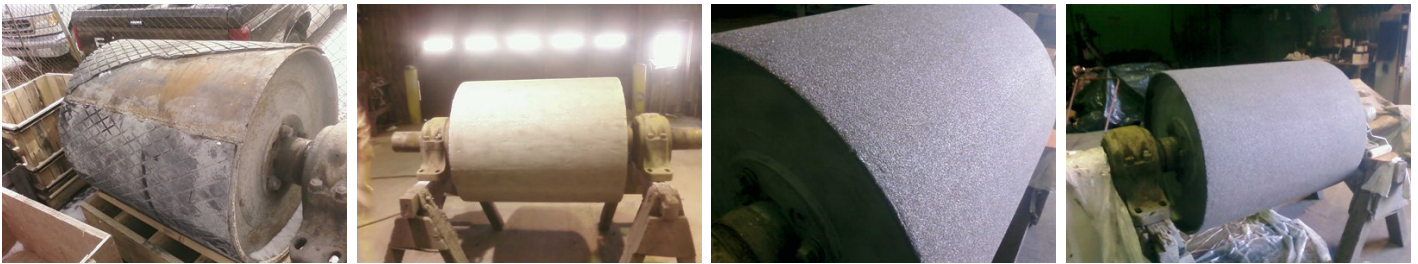
Pieces of rubber lagging were frequently torn loose due to build up. Excessive wear from moisture, chemical attack and abrasive media was causing belt to slip. Belt would often not track properly due to uneven lagging pads.

\* Head pulley with damaged rubber lagging  
Grit blasted pulley  
Belzona non-slip surface  
Completed and ready for service ,

Application carried out in accordance with Belzona Know-How System Leaflet SHM-12. Belzona® 1321 was blinded to rejection with non-slip aggregate.

The application was completed in one day for less than half the cost of conventional lagging, which was lasting less than one year! The durable Ceramic S-Metal grip system eliminated belt slippage and protected the pulley from both abrasive and chemical attack. Original rubber lagging system was lasting less than a year.
