# Belzona Repairs Cavitation Damage on Potable Water Pump.

ID: 1259

Application: CEP-Centrifugal Pumps

Customer Location: Water Treatment Plant, Virginia.

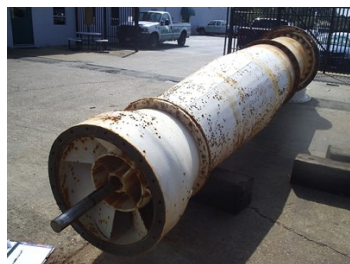
\* 24 inch vertical potable water Pump , \* Suction Bell shown with severe cavitation damage. Pump repaired with Super Metal , \* Pump back in shop vibration issues. Inspection shows minor damage to old repairs , \* Belzona Super E Metal used to repair minor cavitation damage. ,

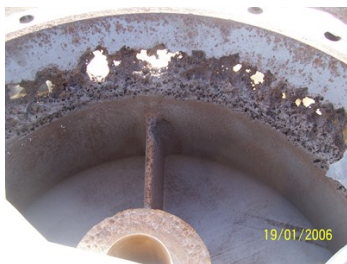
Suction bowl badly damaged by cavitation.

January 2006: Lost metal replaced with Belzona® 1111. Strength added to casing by welding steel stiffeners to outside of casing.
