# Belzona Repairs Cavitation Damage on Potable Water Pump.

Customer Location: Water Treatment Plant, Virginia.

Application: CEP-Centrifugal Pumps

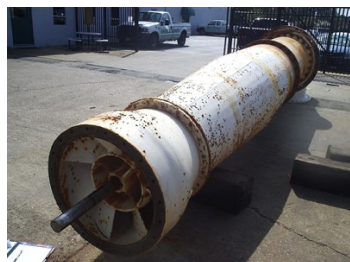
\* 24 inch vertical potable water Pump , \* Suction Bell shown with severe cavitation damage. Pump repaired with Super Metal , \* Pump back in shop vibration issues. Inspection shows minor damage to old repairs , \* Belzona Super E Metal used to repair minor cavitation damage. ,

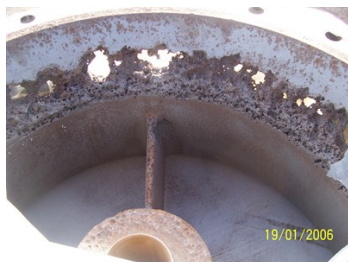
Suction bowl badly damaged by cavitation.

January 2006: Lost metal replaced with Belzona® 1111. Strength added to casing by welding steel stiffeners to outside of casing.
