CAVITATED PUMP DIFFUSER RESTORED WITH BELZONA

ID: 1261

Industry: Water / Wastewater
Application: CEP-Centrifugal Pumps
Substrate: Cast Iron
Products: * Belzona® 1111 (Super Metal) ,

Customer Location: Theme Park, (Southeast) Virginia
Application Date: March 2009

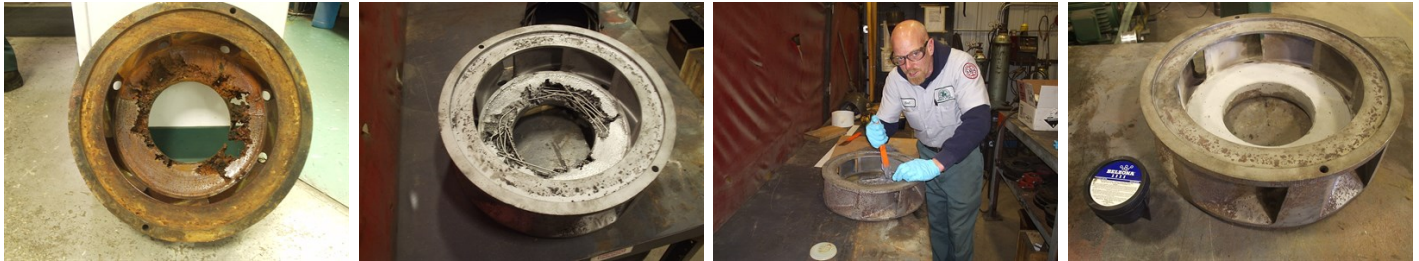
Photograph Descriptions

Cavitation had caused severe metal loss to pump impeller and diffuser. New impeller was available but no diffuser available.

- * Severely cavitated diffuser ,
- * Diffuser blasted and rebar tack welded in place ,
- * Belzona® 1111 application ,
- * Completed repair ,

Application was carried out in accordance with Belzona System Leaflet CEP-1. Pump shop tack welded "rebar" into deeply cavitated areas. Belzona® 1111 applied to replace lost metal. Belzona machined to original diffuser dimensions.
