CHURCH HAS LONG HISTORY WITH BELZONA

Application: RPA-Roof Problem Areas

Customer Location: Church, Richmond, Virginia USA

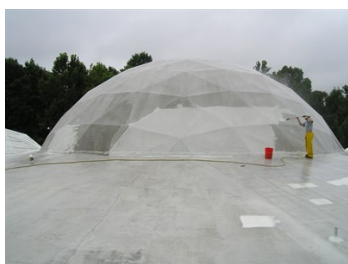
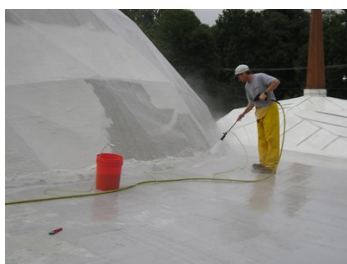
* 1. & 2. Applying Belzona Flexible Membrane ,

Application was carried out in accordance with Belzona Know-How System leaflet RPA-1. Spray application was used to aid application.

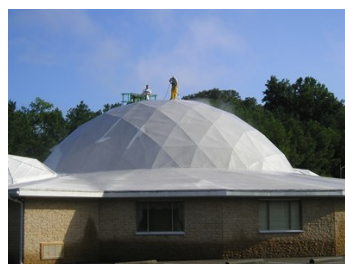
* 3. Spraying the top of the dome ,

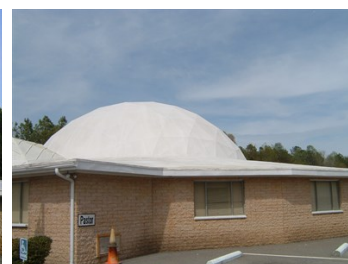
* 4. The roof in 2006 ,

Belzona has provided an attractive and economical solution that effectively sealed the roof for the church. The original tar roof proved unsatisfactory. Belzona® 3111 was applied in the mid 1980s and proved to be a successful solution for approximately 20 years. The Church was so happy with the Belzona solution that they decided to restore the roof with a new application of Belzona® 3111 in 2004. The church continues to look to Belzona for solutions for its structural problems.
