SUCTION BELLS RESTORED WITH BELZONA

ID: 1275

Customer Location: Power Plant, Missouri
Application Date: May 2009

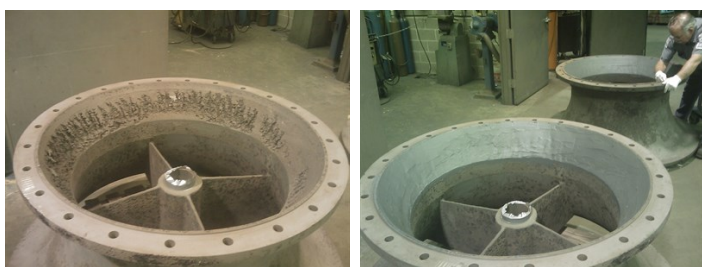
Photograph Descriptions

Erosion had caused serious loss of metal with holes completely through the substrate in places. Loss of efficiency and unscheduled downtime lead client to look at replacing the items.

- * Erosion clearly evident ,
- * Belzona® 1311 being applied ,
- * Belzona® 1321 applied to internal surfaces ,
- * Belzona® 5811 applied to external surfaces ,

Bells were sandblasted to a white to near Application was carried out in accordance with Belzona System Leaflets CEP-3, CEP-4, and CEP-5. Belzona® 1311 applied to bring housing back to original dimensions. The internals were then coated with Belzona® 1321 and exterior with Belzona® 5811.
