BELZONA REBUILDS STAINLESS STEEL PUMP

ID: 1277

Customer Location: *Pulp & Paper Plant, Bulgaria*
Application Date: *August, 2008*

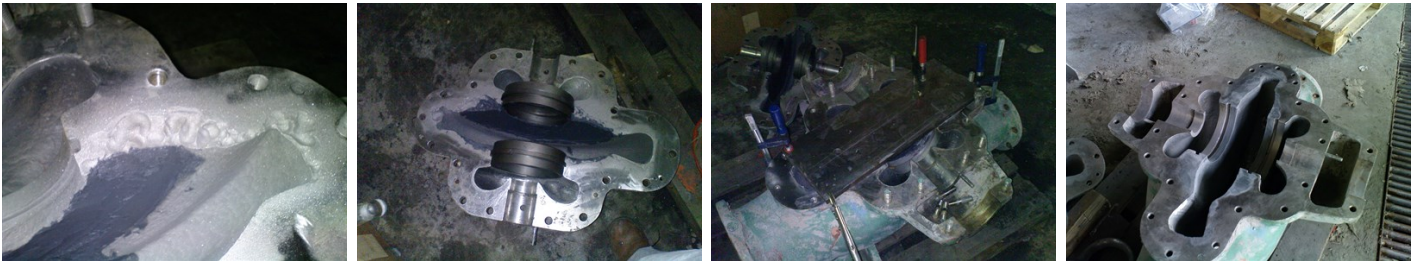
Photograph Descriptions

Loss of internal profiles of the pump casing as a result of corrosion and erosion processes leading to reduced pump efficiency

- * Damage to the pump casing after blasting ,
- * Rebuilding damage inside the casing ,
- * Flat metal plate used as former to rebuild flange faces ,
- * Pump rebuild completed ,

Application was carried out in accordance with Belzona Know-How system Leaflets CEP-1 and CEP-5. After blasting with Aluminium Oxide grit the internal damage was restored with Belzona® 1311. Flange faces & sealing ring seats were rebuilt by forming technique with Belzona® 1111.

Rebuilding and contouring to the original pump profile restored pump efficiency and saved time for delivery and high replacement costs for a new pump.
