BELZONA REBUILDS BEARING SUPPORTS ON HUGE EXCAVATOR

Customer Location: *Open Cast Brown Coal Mine in Poland*
Application Date: *July 1993*

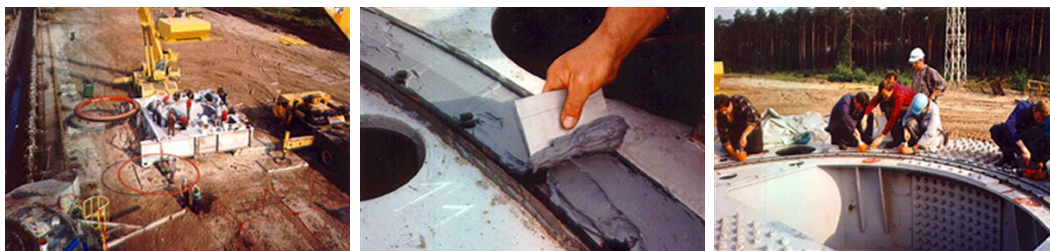
Erosion of support surface for crown bearing

* General view of the excavator partially dismantled for maintenance Application of Belzona® 1111 A team of applicators was required to apply all the Belzona® 1111 quickly, to allow time for the rings to be located ,

Crown bearings of rotational platform of large excavator (superstructure over 400 tons).

The technique allows for 100% support of the bearing and also allows for future replacement, should the bearing fail. The bearing used in this application was a new one.
