BELZONA PROTECTS PIPE ELBOWS FROM ABRASION

ID: 1280

Customer Location: Copper and Gold Mining Operator,
Bulgaria

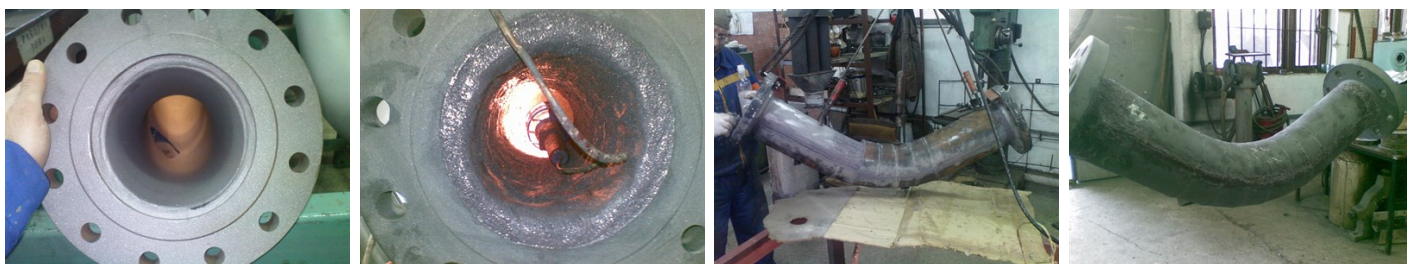
Severe abrasion damage on inside surfaces of the pipe elbows.

* Abrasion damage clearly viewable after blasting
Application of internal protective coating
External bonding of metal doubler plates
Finished protected pipe elbow ,

Application was carried out in accordance with Belzona Know-How System Leaflet SHM-8. Belzona® 1811/1812 have been used to protect elbows from further abrasion attacks. Application was either internal coating (for 6 inch diameter) with Belzona® 1812 or external bonding of metal doubler plates (for 4 inch diameter) with Belzona® 1811.

Previously customer had to replace non-protected elbows every three-five days or to use expensive but unsuccessful welding. Pipe elbows have been and continue to be protected with Belzona, increasing the working live to more than a month. As a result the customer saved money on replacement costs.
