BELZONA REBUILDS OVERSIZED PINTLE HOUSING

Industry: *Marine*
Application: *SOS-Ships and Offshore Structures*

Customer Location: *Dockyard, Bulgaria*
Application Date: *February, 2009*

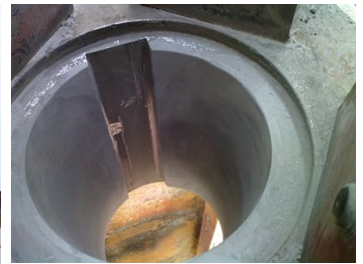
Keyway and rudder pintle housing were oversized due to erosion corrosion and impact.

- * Rudder pintle with false key used as former ,
- * Adjusting unit for rudder pintle positioning ,
- * After application of Belzona® 1111 the rudder stock was positioned ,
- * The oversized housing and keyway restored to exact profile ,

Application procedures were made according to Belzona Know-How System Leaflet SOS-3. The oversized housing and keyway were rebuilt using the rudder pintle with a false key as former. Belzona® 1111 was used for the main repair and Belzona® 1221 was used to fill some voids along keyway.
