# BELZONA REBUILDS OVERSIZED PINTLE HOUSING

ID: 1281

Industry: Marine  
Application: SOS-Ships and Offshore Structures

Customer Location: Dockyard, Bulgaria  
Application Date: February, 2009

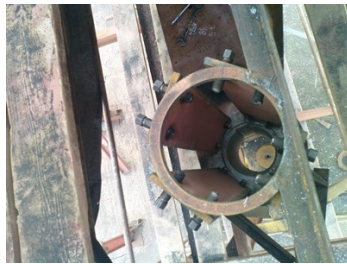
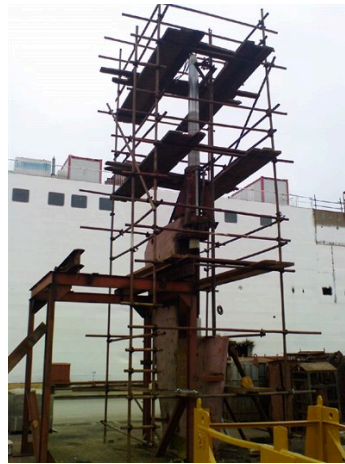
Keyway and rudder pintle housing were oversized due to erosion corrosion and impact.

- \* Rudder pintle with false key used as former ,
- \* Adjusting unit for rudder pintle positioning ,
- \* After application of Belzona® 1111 the rudder stock was positioned ,
- \* The oversized housing and keyway restored to exact profile ,

Oversized housing and keyway of rudder pintle.

Application procedures were made according to Belzona Know-How System Leaflet SOS-3. The oversized housing and keyway were rebuilt using the rudder pintle with a false key as former. Belzona® 1111 was used for the main repair and Belzona® 1221 was used to fill some voids along keyway.

The repair was done on-site and completed in a few hours. In this situation conventional repair by welding and then machining was considered to be time consuming, complicated and too expensive.
