# BELZONA REBUILT HEAT EXCHANGER COVER

ID: 1283

Customer Location: Ship Dockyard, Bulgaria  
Application Date: June, 2008

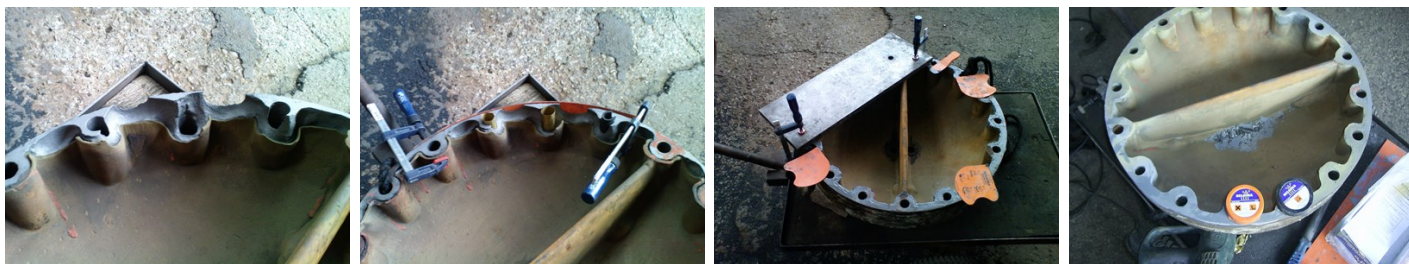
*Damage on the original profile of the cooler top-cover due to erosion/corrosion, led to leaks and loss of efficiency.*

- \* Damage to top-cover clearly evident ,
- \* Formers were used to restore profile ,
- \* Repair of top-cover flange face in progress ,
- \* Finished repair ,

Application was carried out in accordance with Belzona Know-How System Leaflet HEX-2. After blasting the damaged area and flange surfaces of the top-cover were restored by forming technique and Belzona® 1111.

Cost effective and quick method of rebuilding and contouring of the original cooler top-cover profile. Belzona repair fully restored the efficiency of heat exchanger. Significant cost saving to the customer as alternative was equipment replacement.
